DEPARTMENT OF TRANSPORTATION**DIVISION OF ENGINEERING SERVICES**

Quality Assurance and Source Inspection

Contract #: 04-0120F4Cty: SF/ALA Rte: 80 PM: 13.2/13.9File #: 1.28**WELDING INSPECTION REPORT****Resident Engineer:** Casey, William**Address:** 333 Burma Road**City:** Oakland, CA 94607**Report No:** WIR-027257**Date Inspected:** 01-Mar-2012**Project Name:** SAS Superstructure**OSM Arrival Time:** 700**Prime Contractor:** American Bridge/Fluor Enterprises, a JV**OSM Departure Time:** 1730**Contractor:** American Bridge/Fluor Enterprises, a JV**Location:** Job Site

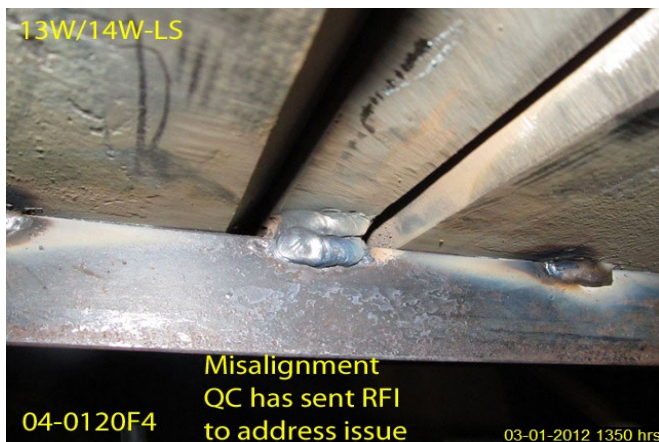
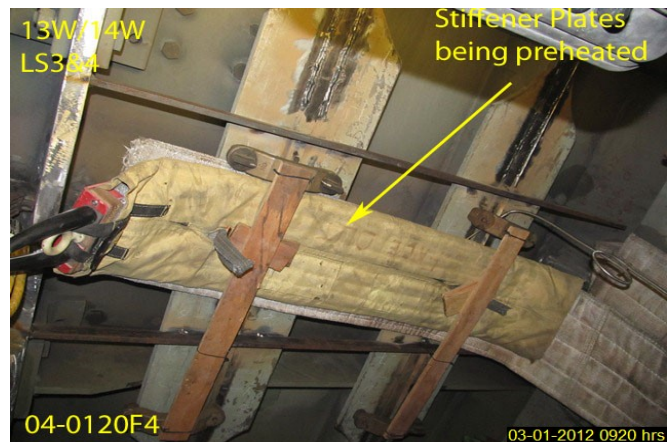
This QAI observed that the contractor had fit up plate stiffeners at 12W/13W @ LS 3-5 and 12W/13W @ LS 4-6. The material being fit is Gr 485 plate stiffeners (ID X3847D-H & J and X4879D-H & J) the dimensions of the plate stiffeners are 18mm x 125 & 130mm x 1500mm Gr 485W. This QAI observed the QC inspector verify the fit up and noted that there is an offset (Misalignment) of the Plate Stiffener to longitudinal stiffeners. The QC inspector mapped the misalignment locations and it was turned in to the contractors engineer to be addressed and sent to Caltrans as a Request For Information (RFI).

This QAI observed welder's Rich Garcia and Jeremy Dolman was using the Shielded Metal Arc Welding (SMAW) process, with electrode E9018 for the Partial Joint Penetration weld in the overhead (4G) position at 12W/13W @ LS 4-6 and 12W/13W @ LS 4-6, for the plate stiffeners. The Welding Procedure Specification (WPS) used was ABF-WPS-D15-1162-4 with a 3.2mm electrodes for these locations with welding amps measured at 126 (Dolman) and 123 (Garcia). The pre-heat for these locations were measured at 100 degrees C (200 degrees F) using thermo-couplers which were verified using a tempstik and infrared gun by the QC. The welder was also observed by this QAI as using a chipping hammer, power grinder and power wire wheel for the interpass cleaning. The QC inspector for this location was Salvador Merino and was observed verifying and documenting the welding

Later in the shift this QAI continued his random observation of the items noted above and observed that the QC inspector had performed Magnetic Particle Testing (MT) of the root pass for 12W/13W @ LS5 and 13W/14W @ LS5&6 the results of the MT was acceptable which was observed by this QAI inspector. The welders, Rich Garcia and Jeremy Dolman continued with the Shielded Metal Arc Welding (SMAW) process, with electrode E9018 for the Partial Joint Penetration weld in the overhead (4G) position. The Welding Procedure Specification (WPS) used was ABF-WPS-D15-1162-4 with a 3.2mm electrodes for these locations with welding amps measured at 125 (Dolman) and 124 (Garcia). The pre-heat for these locations were measured at 100 degrees C (200 degrees F) using thermo-couplers which were verified using a tempstik and infrared gun by the QC. The welder was also observed by this QAI as using a chipping hammer, power grinder and power wire wheel for the interpass cleaning. The QC inspector for this location was Salvador Merino and Steve Jensen and was observed verifying and documenting the welding parameters for this location, along with overseeing the welding operations. At the time of the observations no issues were noted by the QAI.
